Mike Riggs discusses how destructive a small area of damage can be to a sling.

Bad is bad

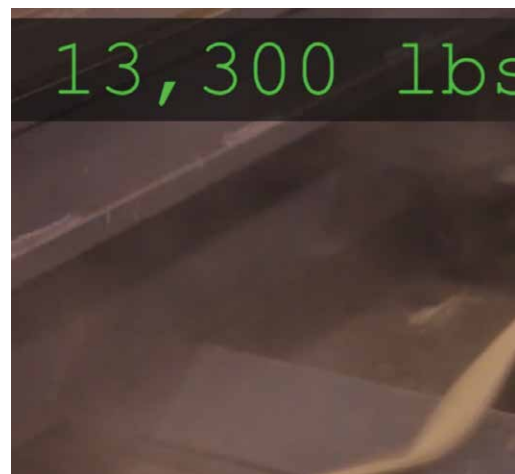
Notice that the standard does not identify how large a hole, tear, snag or cut can be before removing a web sling from service. This is for a very good reason. It takes little damage to create a significant loss of strength in a Nylon Web Sling. The following is one of many tests I’ve conducted on cut webbing. For this test five new single ply 3 inch wide by 6 foot long nylon web slings were pulled to destruction. One sling had no damage – it represents the baseline for the

ultimate or actual strength of the sling versus the minimum breaking strength of the sling. Of the remaining four slings each were damaged by making a cut on one edge of the sling body. The cuts made measured 1/8 inch, 1/4 inch, 3/8 inch and 1/2 inch. After the cuts were made in each sling, the slings were pulled to destruction. As you can see below, the results indicate a dramatic loss of ultimate strength. If you see a cut of any size in a web sling, remove the sling from service.

No Cut – Strait Line Hitch (VRC): 4,800 pounds WLL
Minimum Breaking Strength: 24,000 pounds
Actual Break: 27,512 pounds

1/8 inch Cut Break: 21,910 pounds
 Loss from Baseline Break: 20 percent
 Loss from Min Break: 9 percent

1/4 inch Cut Break: 17,670 pounds
 Loss from Baseline Break: 36 percent
 Loss from Min Break: 26 percent

3/8 inch Cut Break: 15,800 pounds
 Loss from Baseline Break: 43 percent
 Loss from Min Break: 34 percent

1/2 inch Cut Break: 14,000 pounds
 Loss from Baseline Break: 49 percent
 Loss from Min Break: 42 percent

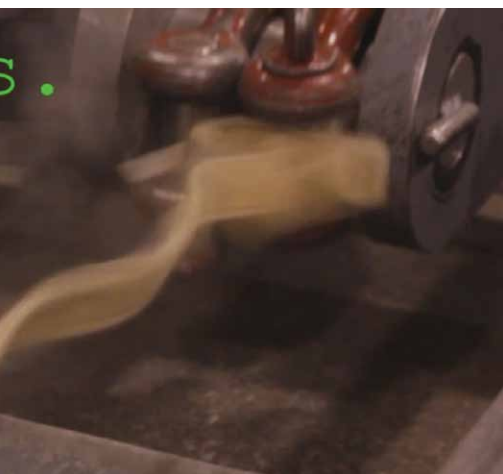
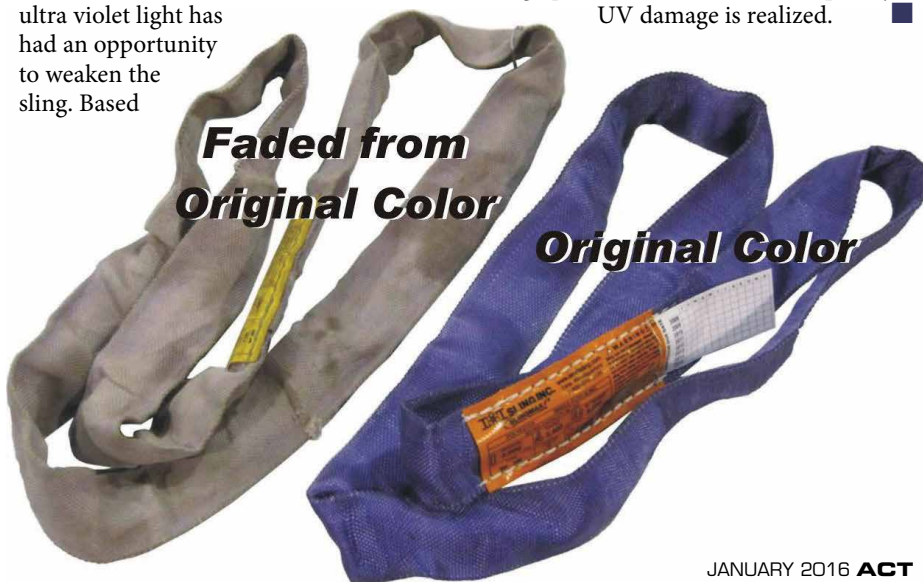
on testing and information from three manufacturers, and the textile industry, the best protection from UV damage of sling fiber and your skin is dark, thick, tight knit material. Roundslings with light colored jackets can lose up to 40 percent of their ultimate strength over a six month period in the Florida, California or Tennessee sun. In the roundslings color spectrum, white, tan, gray and yellow are the least protective covers, while red, dark brown, dark green and black are your best protectors against UV damage. The more light that can shine through the sling’s protective cover the more quickly UV damage is realized. ■

However, it does state in ASME B30.9-10.3 Effects of Environment, “(a) Slings should be stored in an area where they will not be subjected to mechanical, chemical, or ultraviolet damage or extreme temperatures. The key identification of UV degradation for the inspector is: when a roundslings color is not identifiable to remove it from service as ultra violet light has had an opportunity to weaken the sling. Based
